# Corrosion threats and strategy to secure mechanical integrity of Dung Quat refinery

**Mai Tuan Dat**

Binh Son Refining and Petrochemical JSC

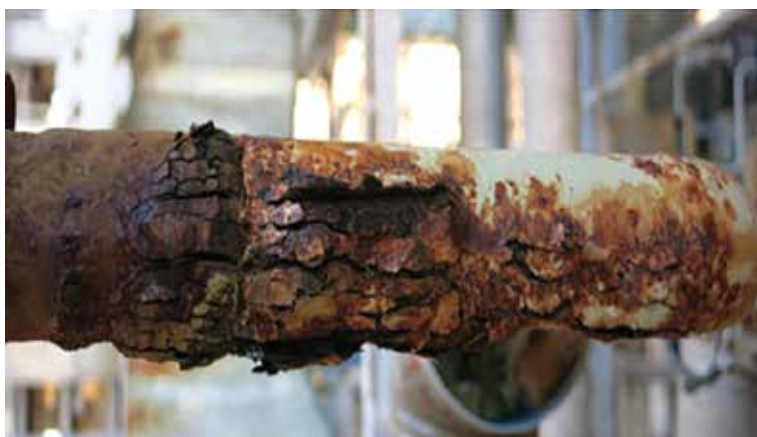
Figure 2. Image of a CUI.

Firstly, corrosion under insulation (CUI) was recognised as a "silent killer" mechanism in the plant due to a high number of damages recorded. Mentioned in NACE Standard Practice SP0198, "Corrosion under insulation has been occurring for as long as hot or cold equipment has been insulated for thermal protection, energy conservation, or process stabilisation" [3]. In Dung Quat refinery plant, the level of threat by CUI was fast-tracked by the local weather conditions with a high humidity and salty air and a very long monsoon season (approximate of two months continuously). In addition, it is believed that the existence of chlorides in the atmosphere accelerates CUI damages.

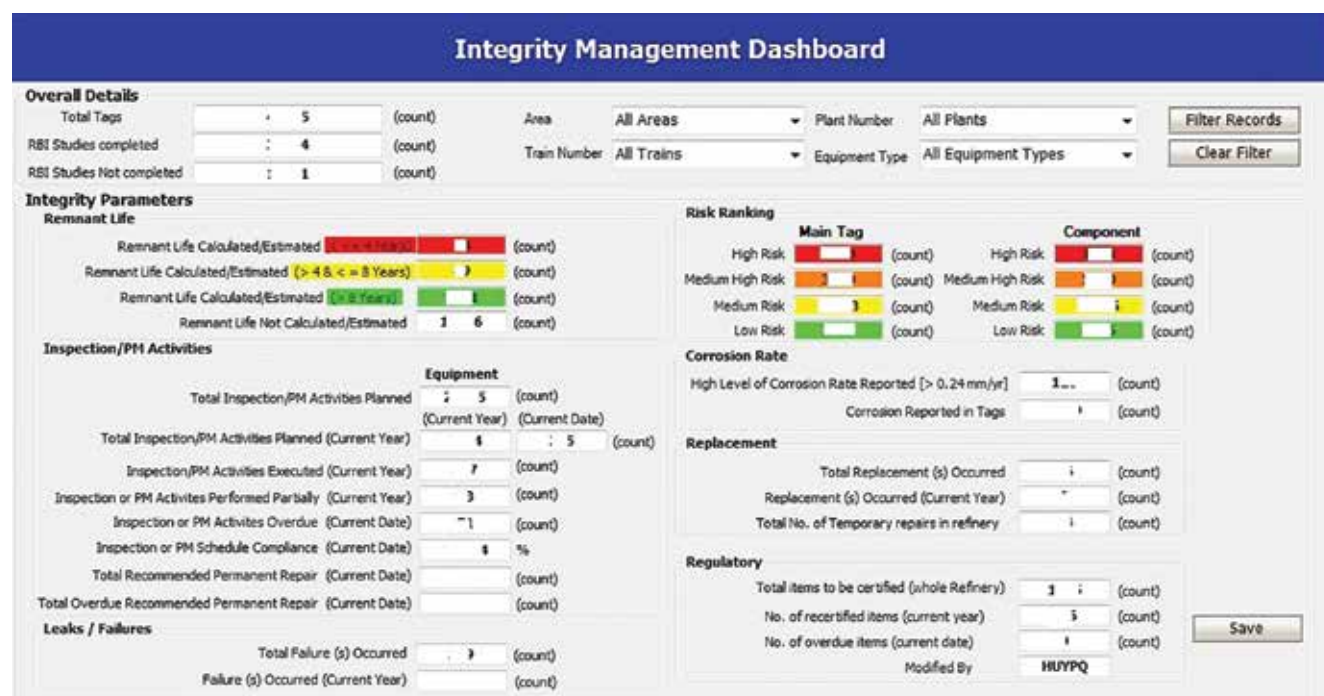
Figure 3. CIMS dashboard window.

A mechanical integrity dashboard was additionally

developed by BSR inspectors providing main KPIs such as the number of assets having a remaining lifetime of less than 4 years, re-certification compliance, and inspection schedule compliance rate, etc.
